248977 KIT REPLACES FAILED 265317 AUXILIARY FIELD RECTIFIERS ON 7.5 kW SETS

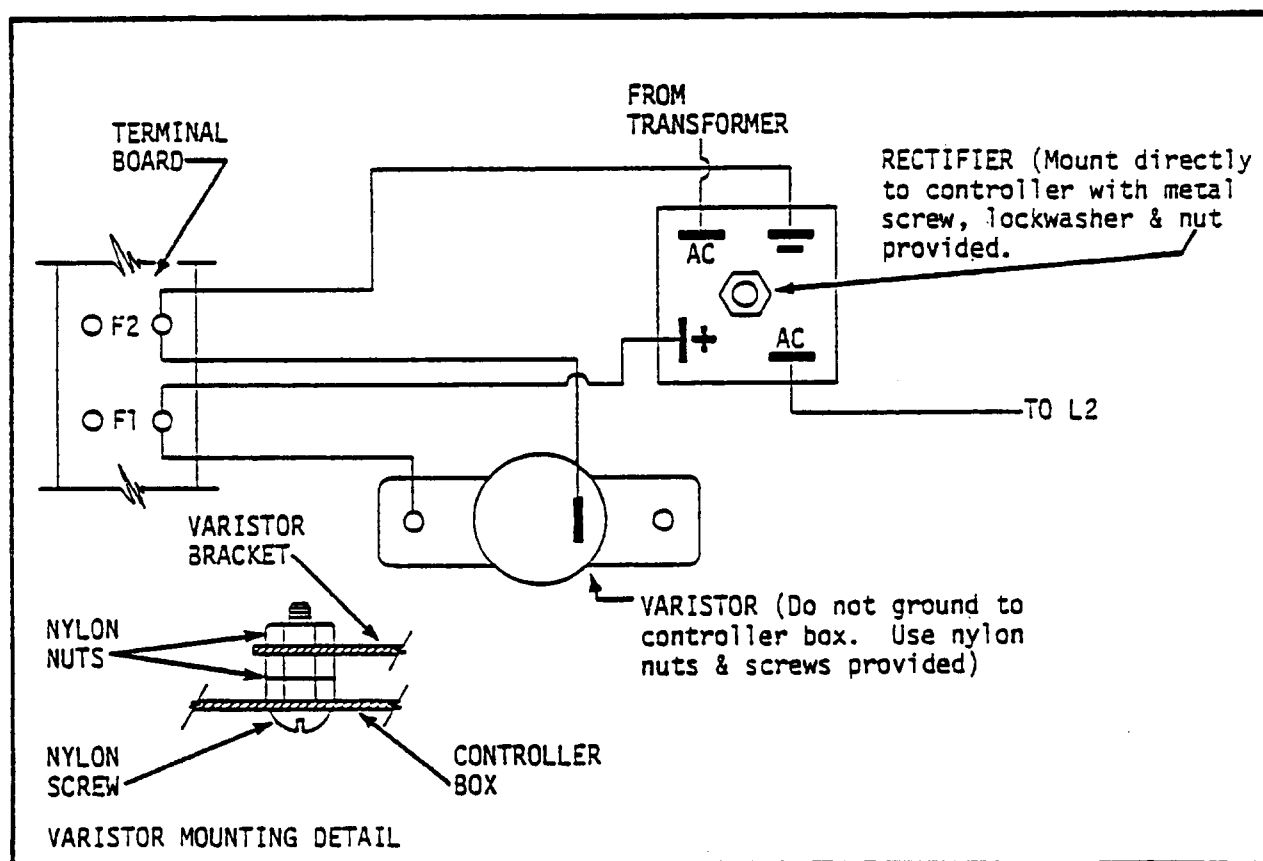
Service Kit 248977 includes a solid state rectifier and varistor plus mounting hardware to replace failed 265317 selenium rectifiers. Transient voltages which occur when heavy loads such as air conditioners or motors are connected or disconnected from the set have caused failure of the selenium rectifier.

The varistor, which functions to "clip" the transient voltage when it gets too high, prevents the spike from reaching and affecting the solid state rectifier.

Remove the failed selenium rectifier and install the solid state rectifier and varistor as shown below.
