## SERVICE BULLETIN

Model: 14/20RES/L, 14/20RESA/L and 48RCL

Subject: Recent Controller Updates and Engine Hunting Troubleshooting Tips

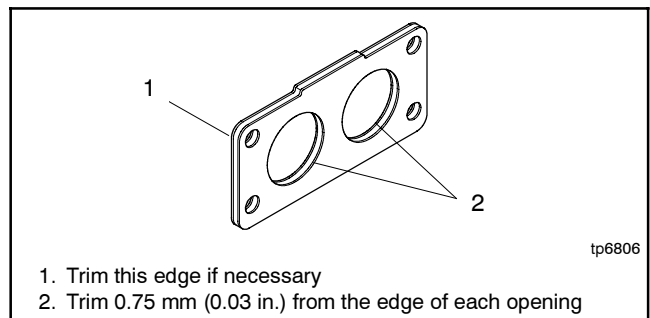
**Figure 3** Trimming the Carburetor Gasket

13. Are the bushings worn, causing excessive movement of the linkage?
  - a. Yes? Replace the bushings.
  - b. No? Proceed to the next step.
14. Is the carburetor gasket interfering with the throttle plate or linkage?

- a. Yes? Always trim the carburetor gasket and test the operation before replacing the carburetor. See Figure 3.

**Note:** Engines with serial numbers 4223605221 or higher have a new carburetor gasket that does not require trimming.
